Application CH1. Automotive Speaker Inspection.

Solution: Stand-alone inspection station retrofitted onto an existing manual inspection station.

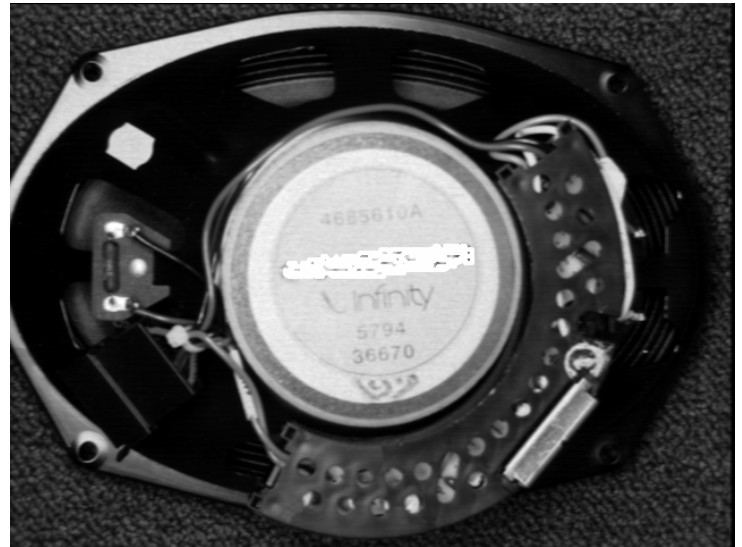
Figure 1: Automotive Speaker

Parts are manually loaded onto a fixture where a variety of components are assembled onto the speaker. Two cameras and light sources illuminate the part from the top. After all components are assembled, the operator touches a button commencing the automated inspection. If the part passes, a green light is illuminated and the part can be removed from the fixture; if the part fails, a red light is illuminated and the part is locked in the fixture for assessment by supervisory personnel.
