Figure 1: Automotive Steering Component

Problem: A manufacturer of automotive steering components needed to verify manufacturing process consistency. A machine vision system was to automatically inspect manufactured parts for process deviation during the manufacturing process. Actual measurements were not as important as the difference in measurement from one inspection to another.

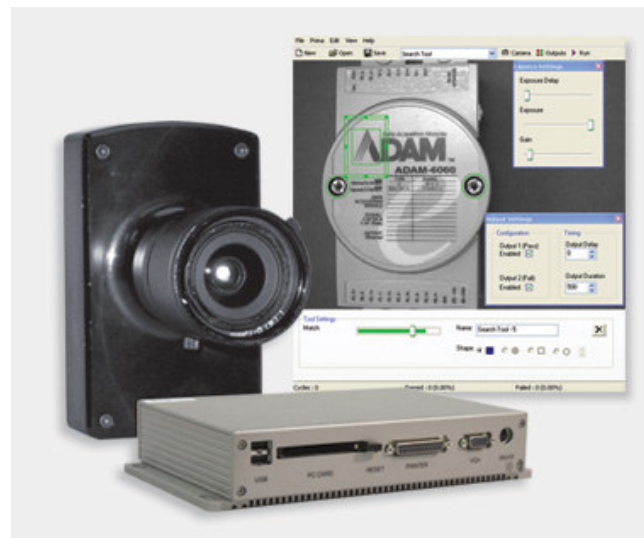
Figure 2: Validator Product
